WYO THEATER

INTERIOR AND EXTERIOR PREDEVELOPMENT WORK
TASK 1

2020.12.20

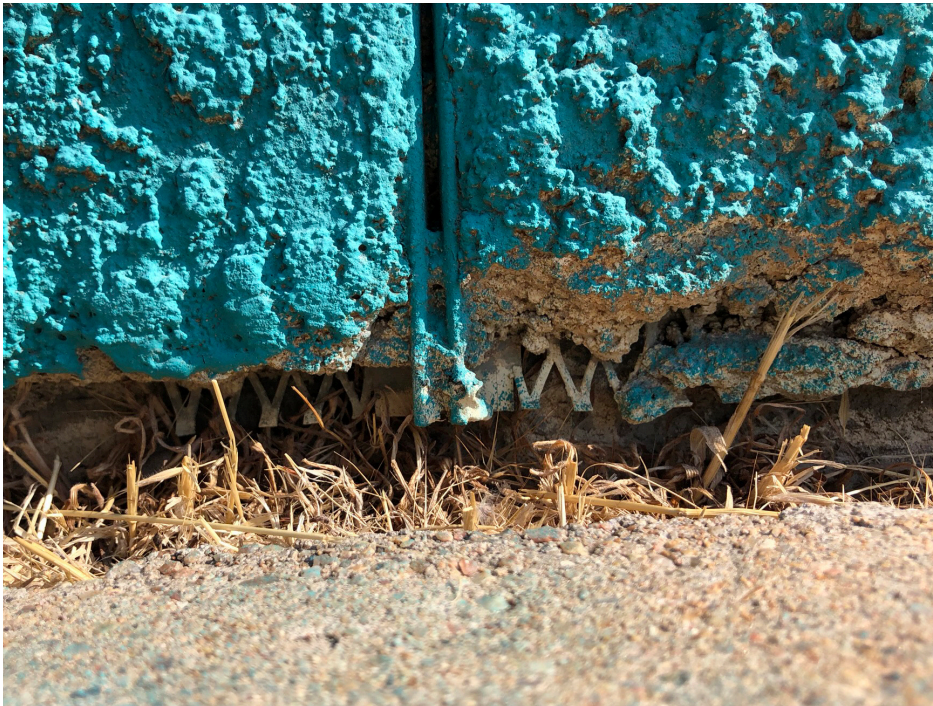
MISSING STUCCO

The stucco is damaged at the base of the north and south wall and should be removed and properly patched. Overall the stucco is in good condition with no signs of cracking.

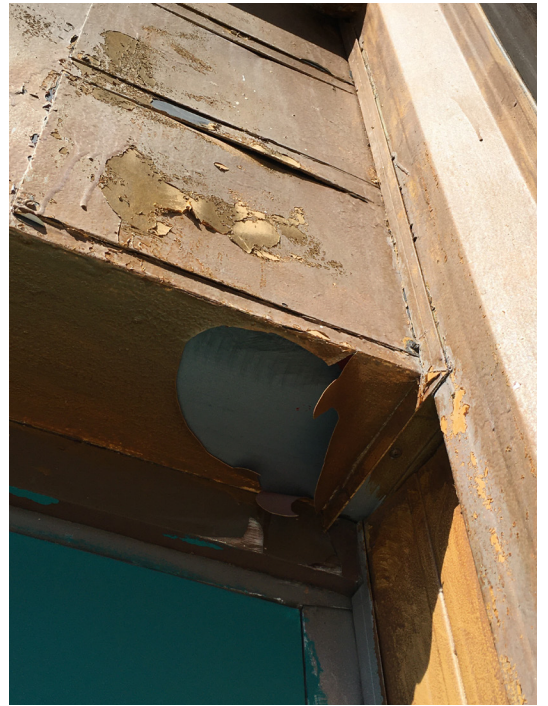
LAYERS OF PAINT FLAKING OFF

The overall condition of the facade is in good condition with some repair work required. The non-historic paint is a latex paint and should be removed to reduce spalling and any water capture issues. The paint installed on the Marquee and other metal panels was done without removing the original paint and is now flaking off. All paint should be properly removed and new paint installed.

Remove all paint on all four facades, clean storefront, remove non-historic vertical metal panels, and non-historic terracotta base. Repaint all stucco with low VOC exterior paint, clean and re-seal all storefront, Marquee, and display cases. Replace non-historic entrance doors with historic replica doors. Repair and replace any missing metal flashing and banding on Marquee. Install new glazed terracotta at sections that are damaged or missing at the display cases. Replace all exterior doors and install new garage door on the east side. The Neon sign may need to be rehabilitated.

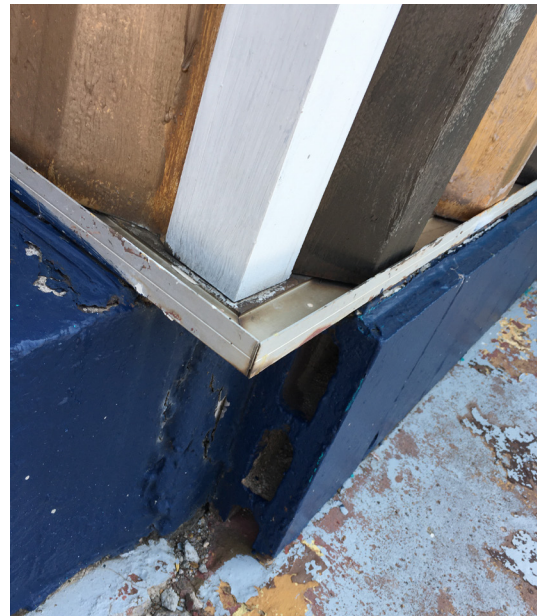
The non-historic terracotta base was improperly installed directly on the sidewalk and should be removed, along with the non-historic vertical metal panels. Sections of the historic terracotta base are damaged or missing. It should be repaired and replaced with matching materials.

NON-HISTORIC TERRACOTTA BASE ON SIDEWALK

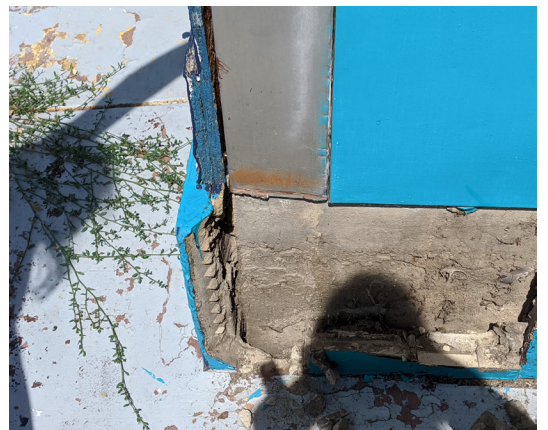
MISSING TERRACOTTA BASE

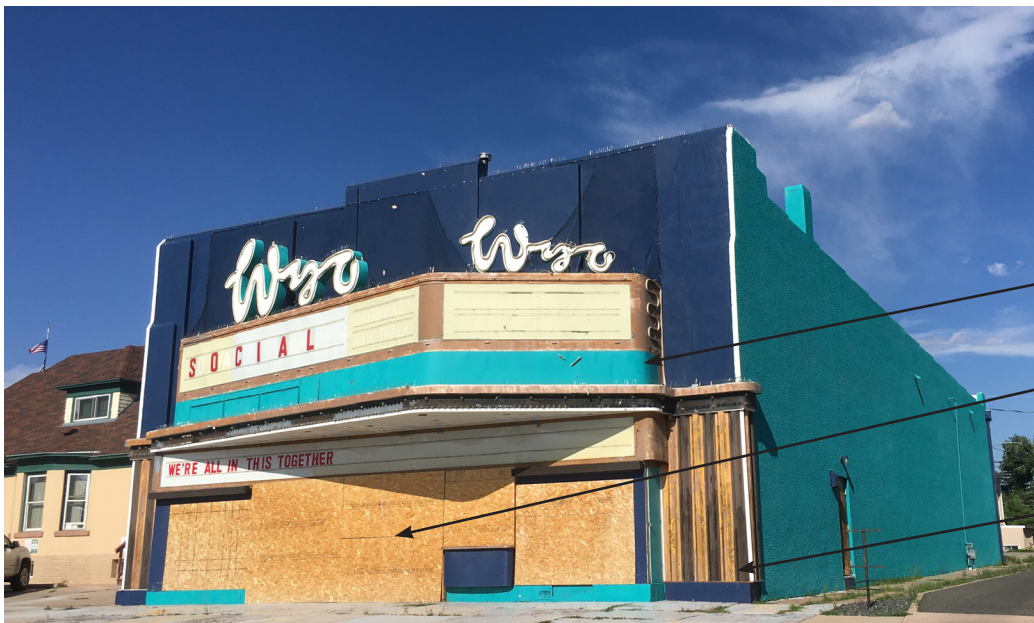
LAYERS OF NON-HISTORIC PAINT

REMOVED HISTORIC AND REPLACED WITH NON-HISTORIC ENTRANCE DOORS

NON-HISTORIC VERTICAL METAL PANELS AND TERRACOTTA BASE

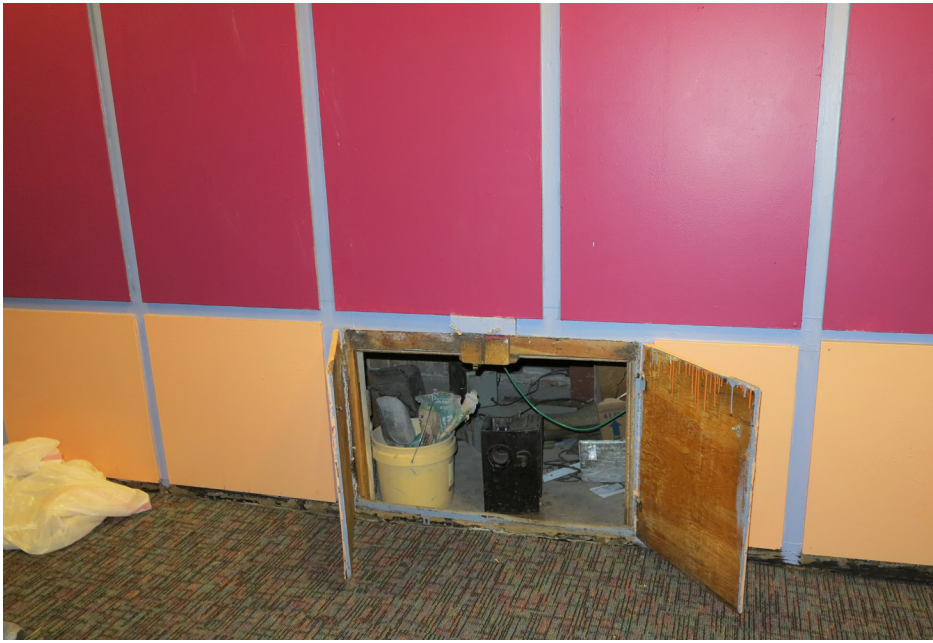
LOBBY: NON-HISTORIC WALL FINISHES ADDED IN 2014

The Lobby will be renovated with new flooring, light fixtures, paint, and floor base. A new ticket office and a concessions counter and kitchen will be added.

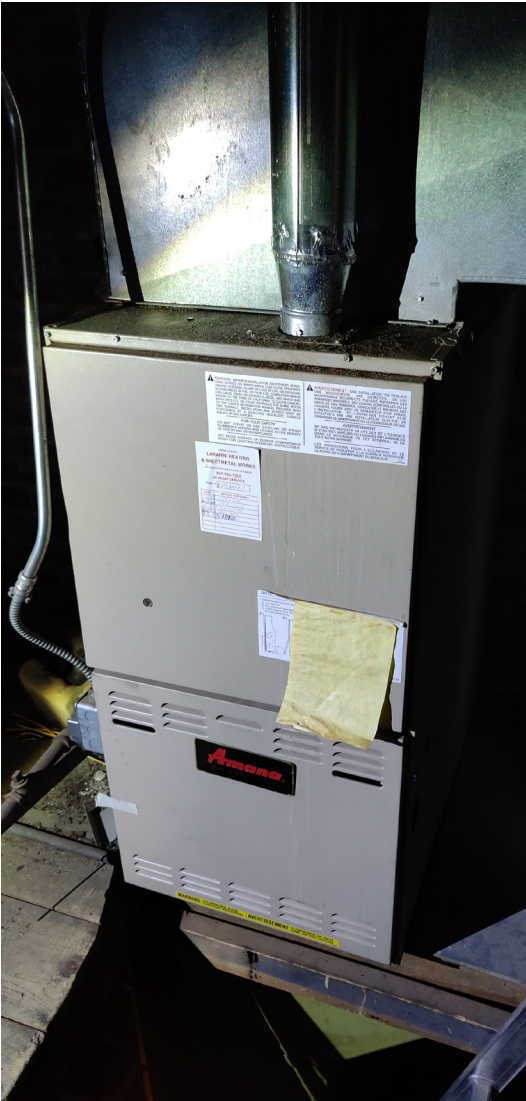
EXISTING MECHANICAL SYSTEM

Remove all existing mechanical systems from the building. Provide new gas-fired furnaces with split-system cooling to all spaces per the following:
